22/01160/F - Drill Service Ltd, 89 Albert Road, Horley

**New Dwelling to rear of
5 Carlton Road, Redhill
RH1 2BX**

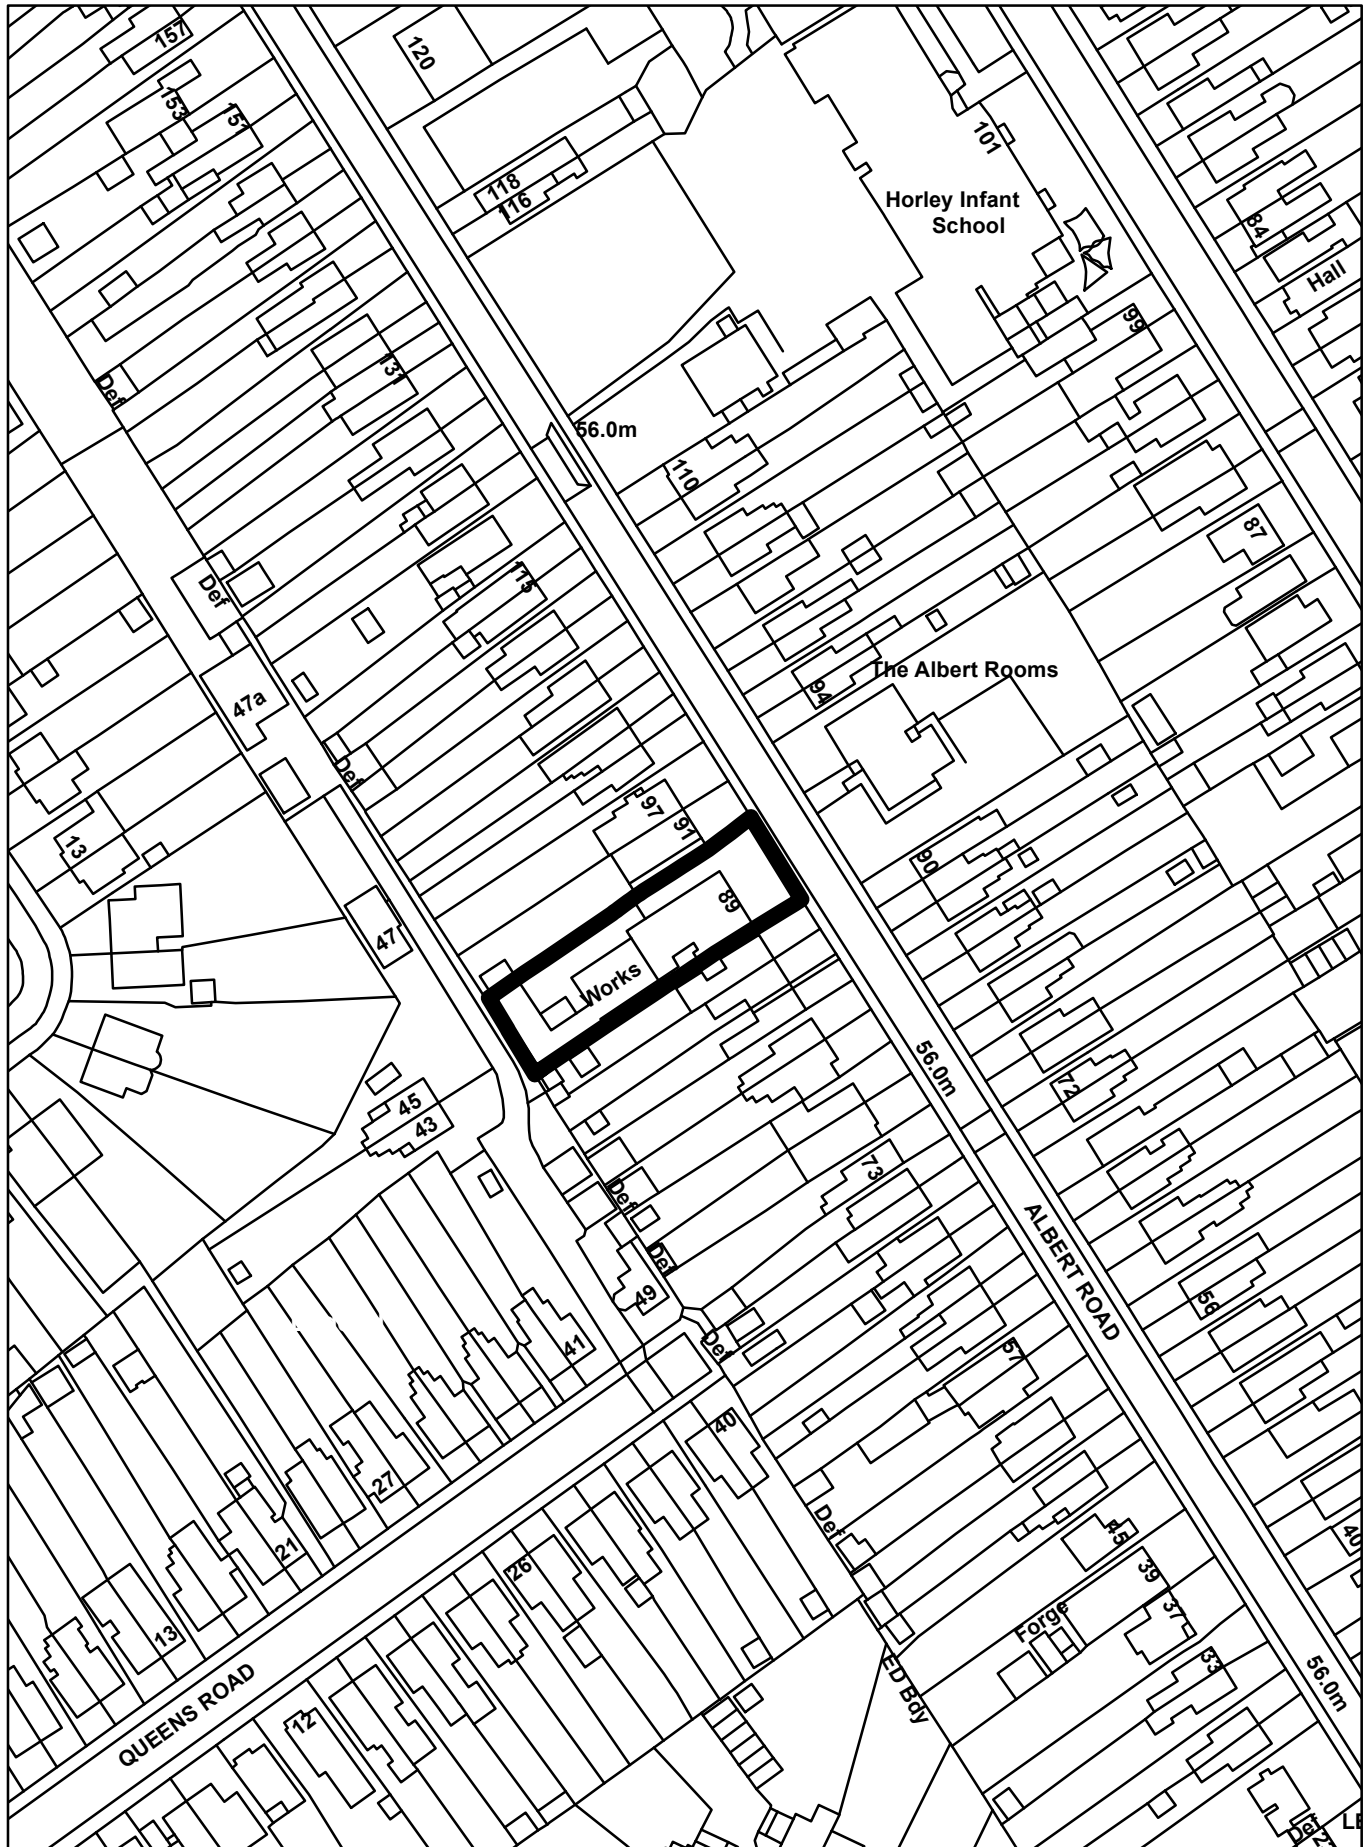
Drawing No. CRB / P22 / 05

PROPOSED SITE LAYOUT

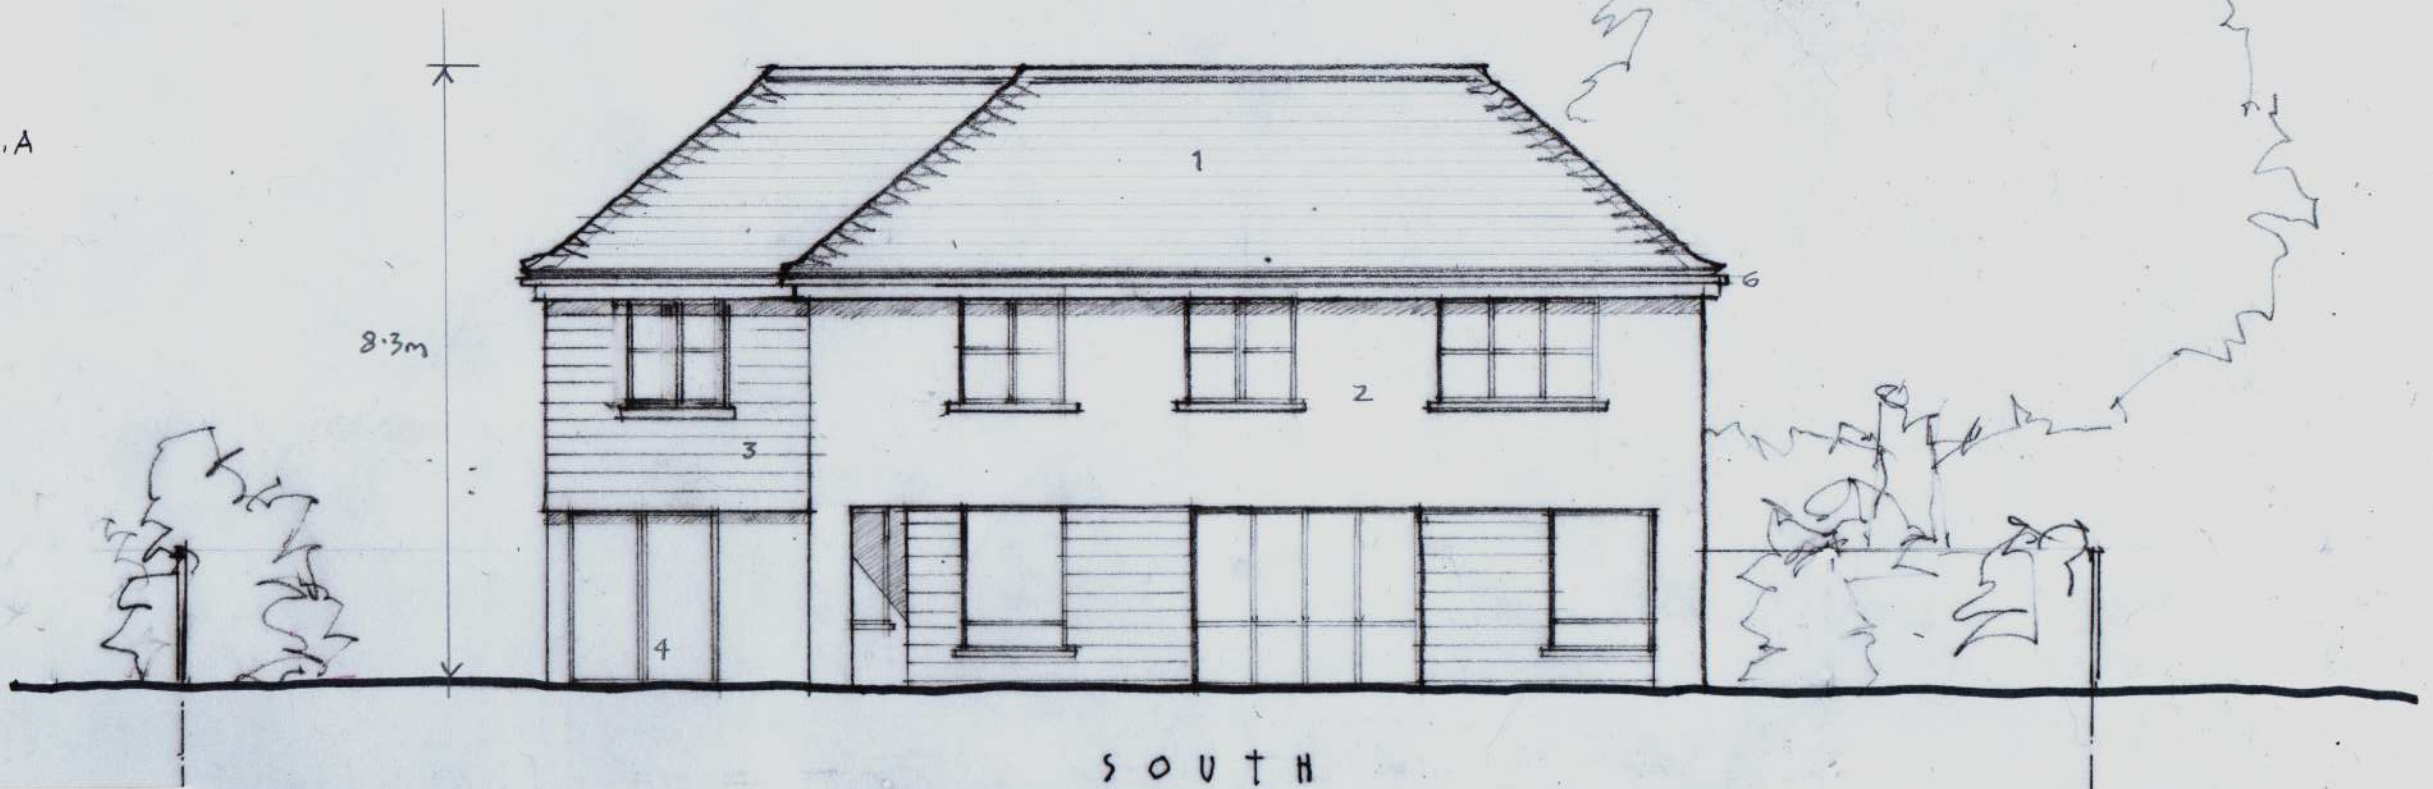
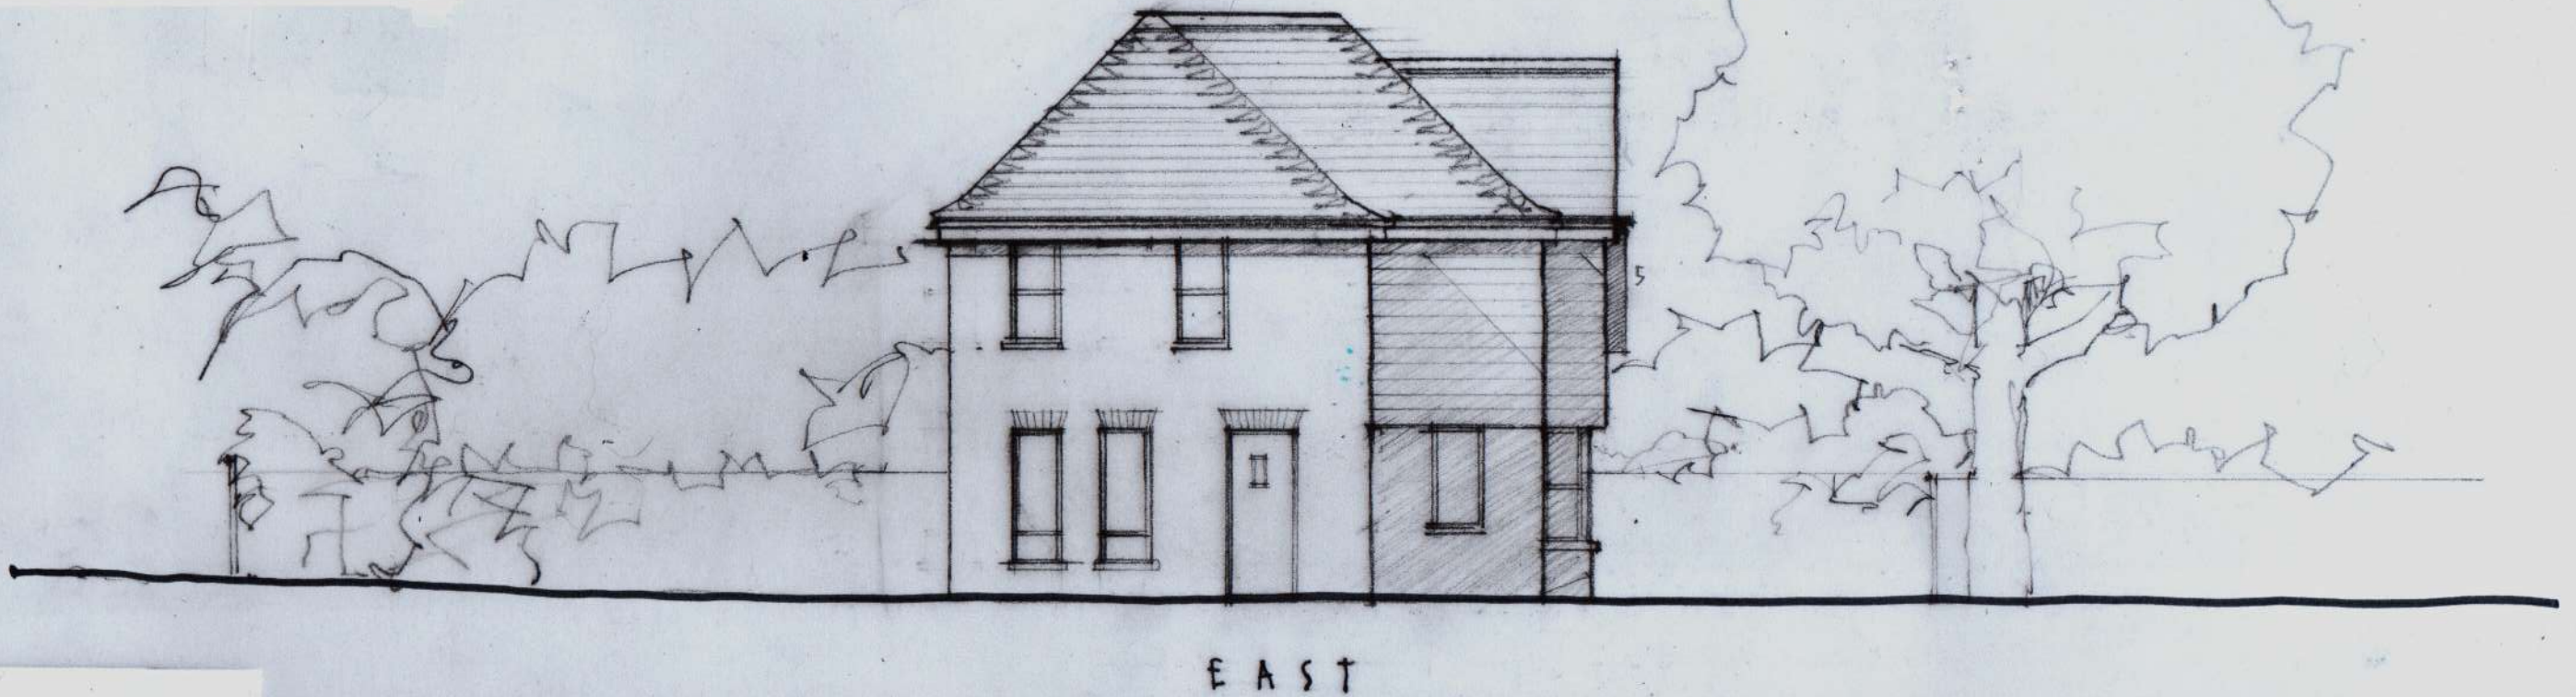
Drawing No. CRB/P22/11 Rev.A

**PROPOSED
SOUTH AND EAST ELEVATIONS**

- 1 RECLAIMED CLAY 'TILEHURST' ROOF TILES
- 2 RECLAIMED LONDON STOCK BRICK
- 3 TREATED TIMBER CLADDING OR MILLBOARD
- 4 TIMBER DOORS ; UPVC WINDOWS
- 5 LEAD CLADDING
- 6 BLACK RAINWATER GOODS

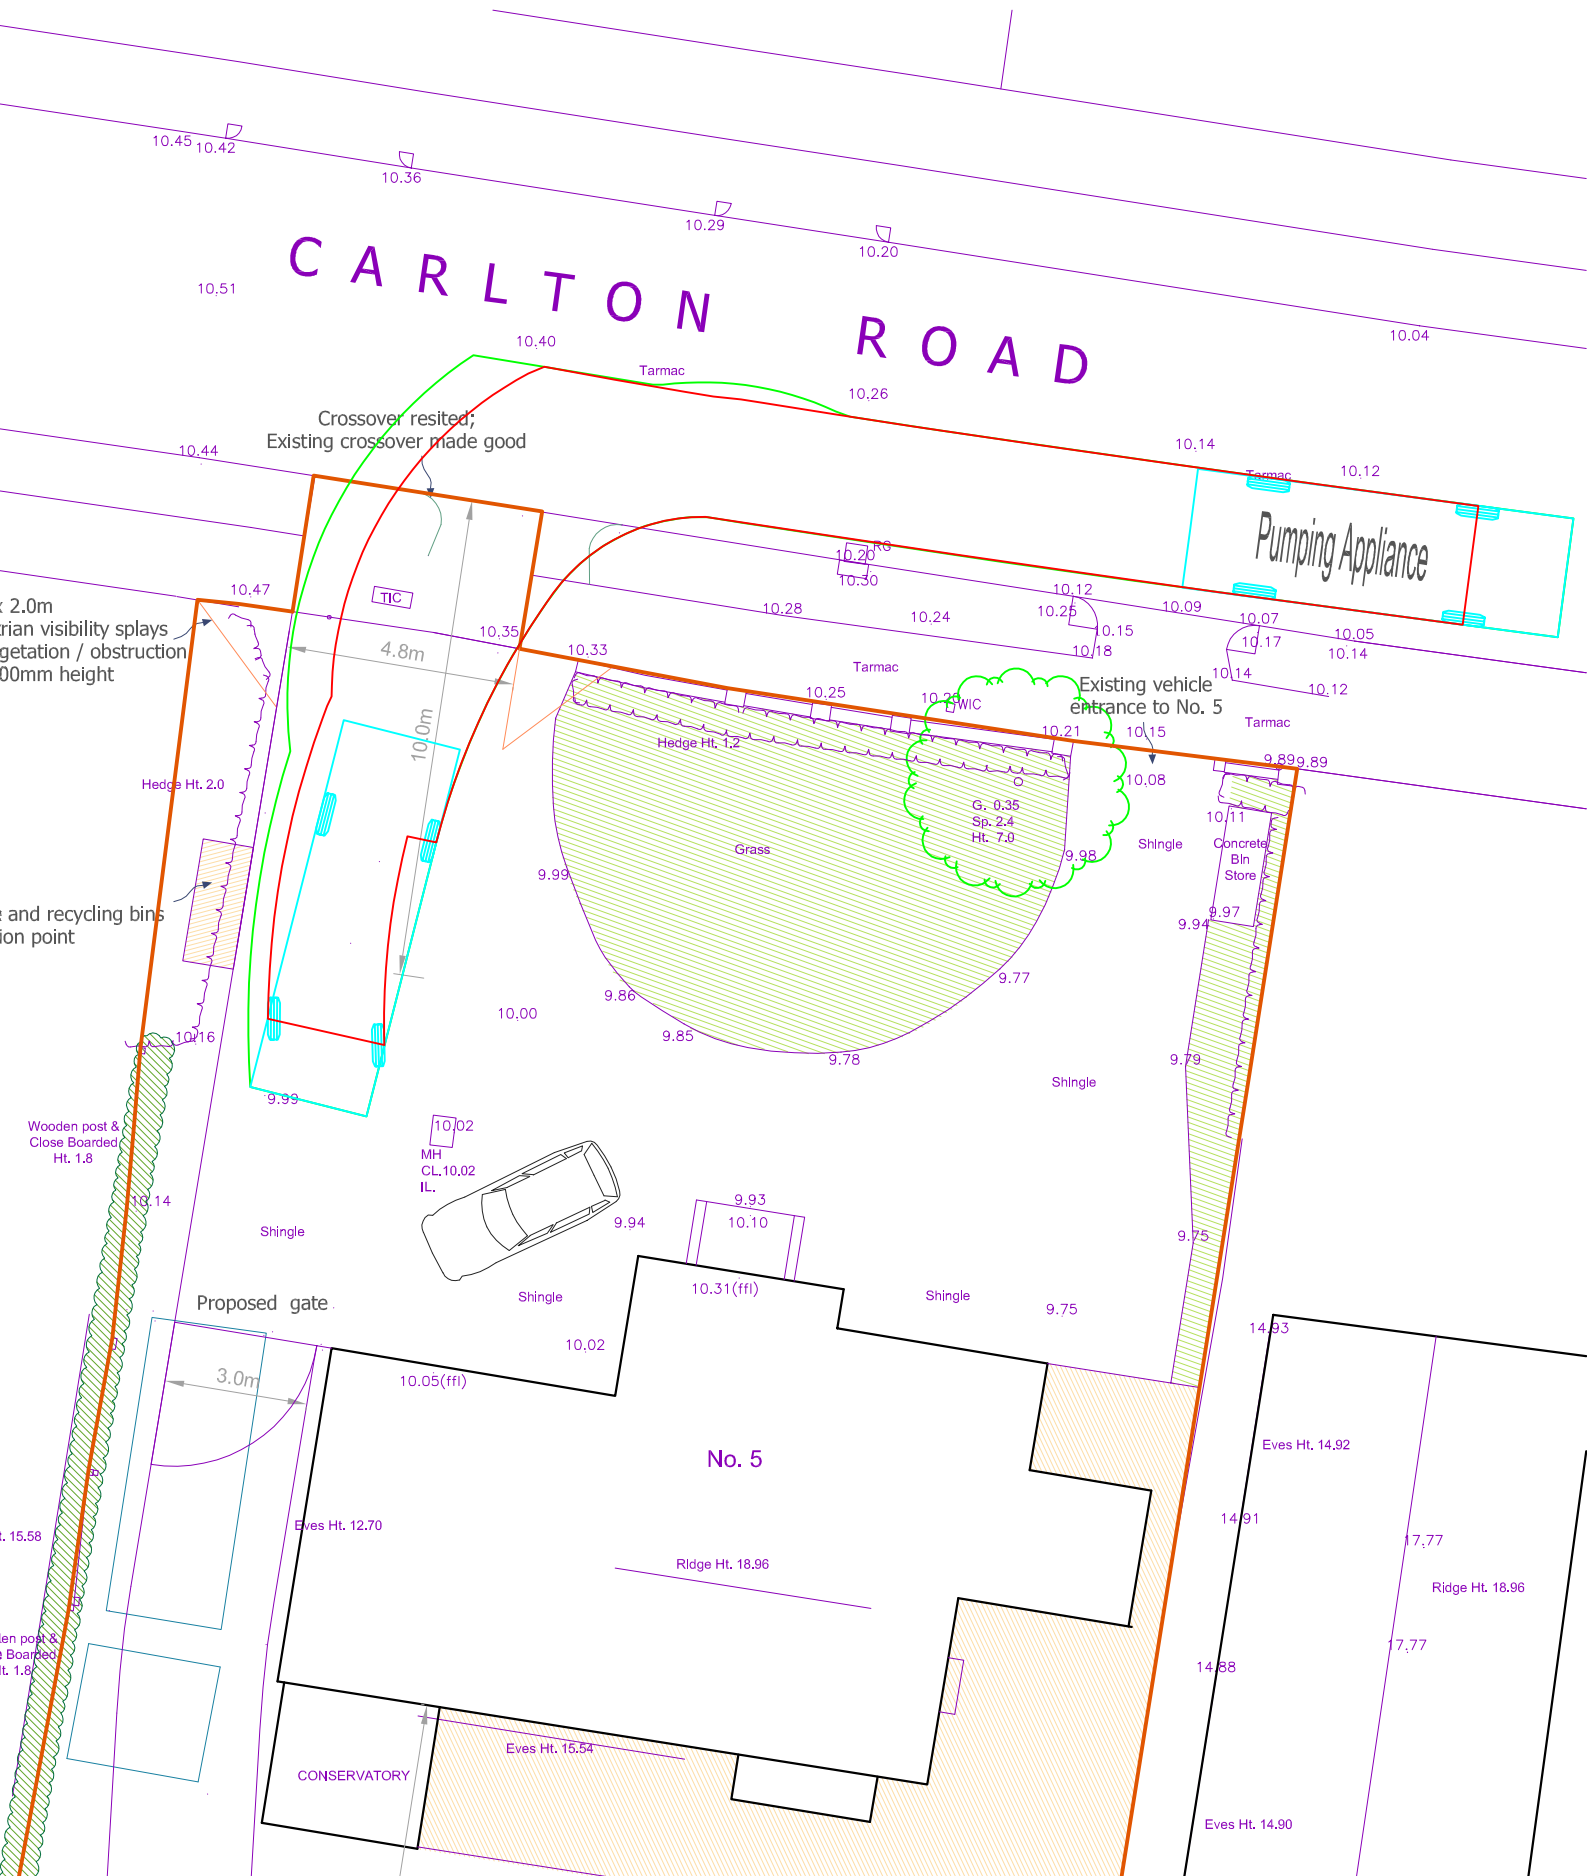
EXTRACT FROM DRAWING NUMBER CRB / P22 / 04
Illustrating Highways Consultants' advice regarding required minimum width of
crossover (4.8m)
